# An anniversary - 25 years of outdoor weathering of pigmented building materials

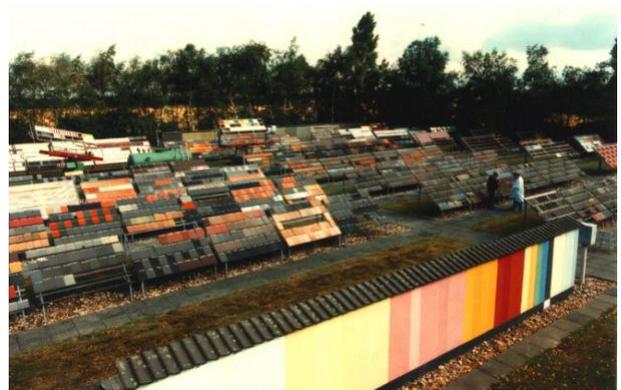
Photo 2: Krefeld weathering station

The first weathering tests at the weathering station near the Uerdingen production site (Photo 2) were carried out using paving slabs, rendering and mortar.

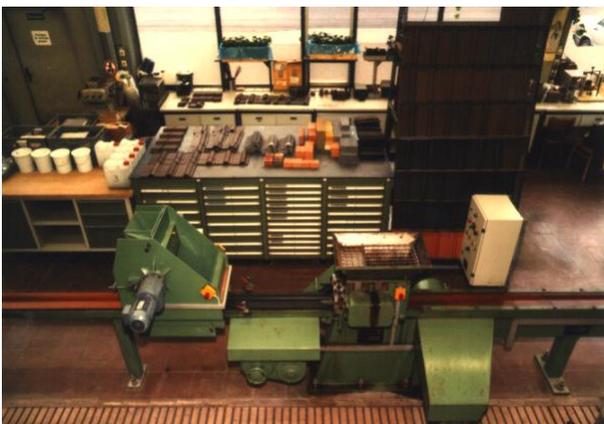
Photo 1: Concrete roof tile machine (extrusion press), Schade (1970)

A compacting machine from Rino has been available since around 1968 for the manufacture of paving slabs. Machinery from Schade for manufacturing concrete roof tiles was added in 1970 (Photo 1). This can be used to produce small, non-corrugated products.

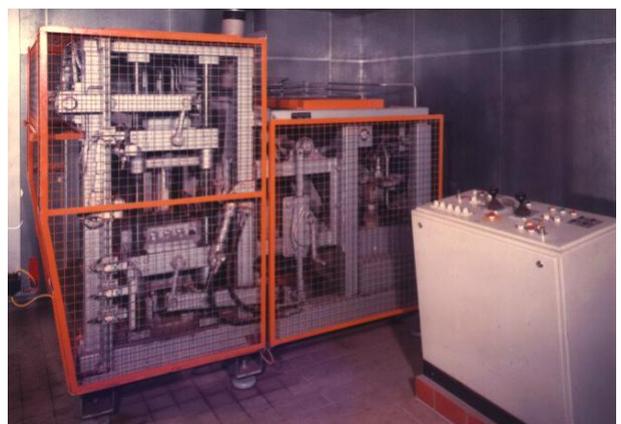
Photo 3: Concrete paver machine (Board machine), Henke (1982)

Concrete pavers are an important product group in which iron oxide pigments are used. A concrete paver machine, also from Henke, was purchased in the early 1980s (Photo 3) so that realistic testing of weather stability could be carried out. Up until then, concrete pavers were produced on the compacting machine, i.e. in a way not usual in the industry.

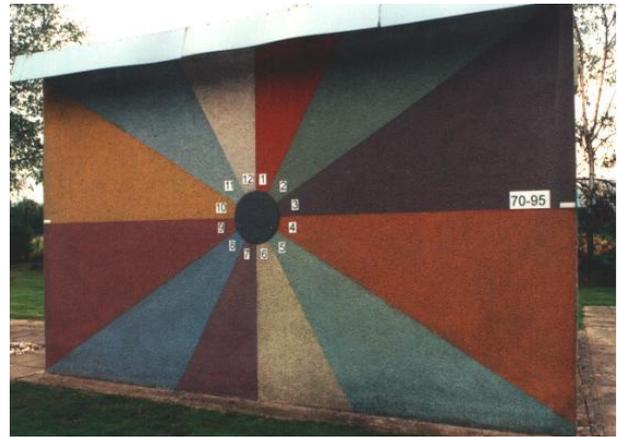
**Photo 4: Mineral rendering, Weathering commenced: 1970, Photo taken: 1995**

1 = 3 % Bayferrox® 110; 2 = 3 % Chrome Oxide Green GN; 3 = 3 % Bayferrox 660; 4 = 3 % Bayferrox 960; 5 = 3 % Le 70; 6 = 3 % LG 200; 7 = 3 % Bayferrox 180; 8 = 3 % Lightfast Blue 100; 9 = 3 % Bayferrox 140; 10 = 3 % Bayferrox 920; 11 = 3 % Ue 5015 (trial product); 12 = 3 % Tronox® A

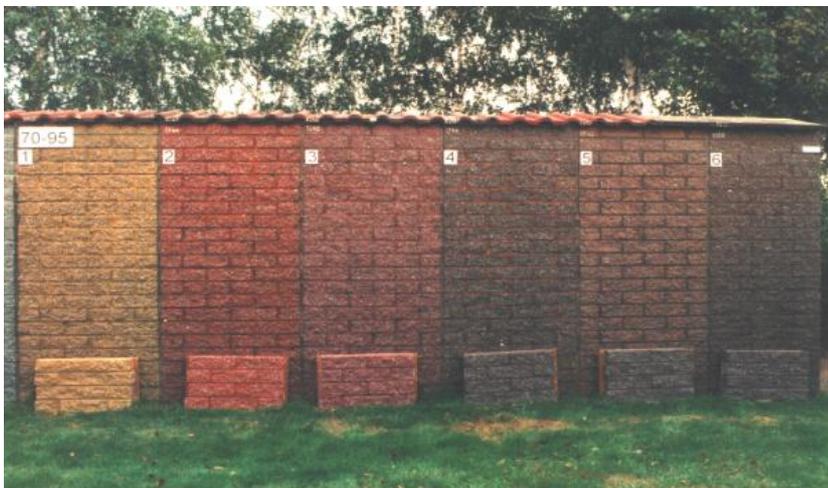
**Photo 5: Concrete masonry blocks (un-weathered reference samples in foreground), Weathering commenced: 1970, Photo taken: 1995**

1 = 5 % Bayferrox 920; 2 = 5 % Bayferrox 120; 3 = 5 % Bayferrox 160; 4 = 5 % Bayferrox 686; 5 = 2,7% Bayferrox 110 I Carbon Black 2 (70 : 30); 6 = 5 % Bayferrox 663

The first thing to note is that pigmented building materials in many variations have been weathered at the Krefeld station for more than a quarter of a century. Results are available for a number of specific investigations, for example, the influence of the raw materials, the water/cement ratio or the manufacturing conditions. The long-term weather stability of inorganic color pigments such as iron oxides, titanium dioxides and chrome oxides has been demonstrated in building materials manufactured under standard industry conditions. This can be shown very impressively by the oldest test sample. Photo 4 shows a wall covered with mineral rendering containing various inorganic color pigments which has been weathered for 30 years. The following photos show the relationship between weather stability and the pigments used in other building materials. Photo 5 shows concrete masonry blocks and Photo 6 calcium silicate brick, both containing inorganic color pigments and both weathered for around 25 years.

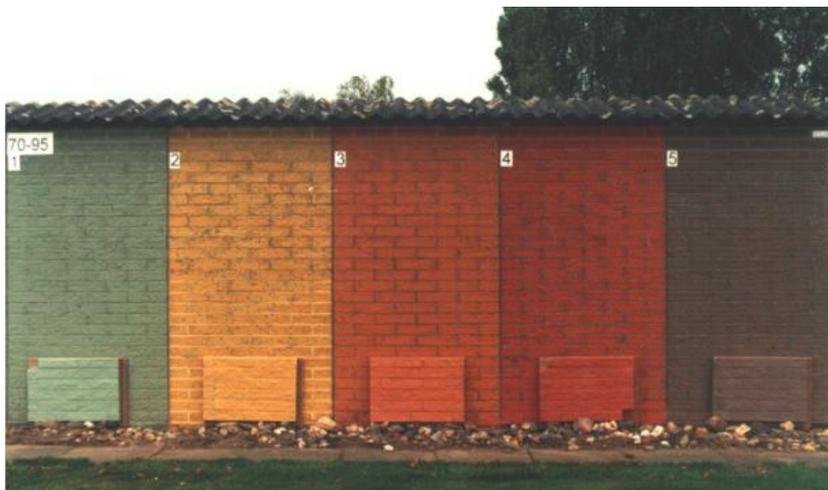
**Photo 6: Calcium silicate bricks (un-weathered reference samples in foreground) Weathering commenced: 1970, Photo taken: 1995**

1 = Chrome Oxide Green GN; 2 = 1 % Bayferrox 920; 3 = 1 % Bayferrox 960; 4 = 1 % Bayferrox 110; 5 = 2 % Bayferrox 660/6

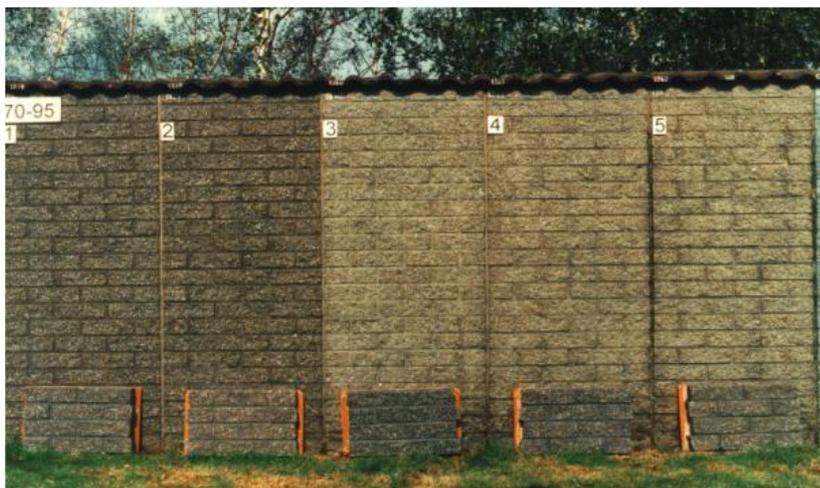
**Photo 7: Concrete masonry blocks (unweathered reference samples in foreground) Weathering commenced: 1970, Photo taken: 1995**

1 = 5 % Bayferrox 318; 2 = 3.5 % Bayferrox 320; 3 = 2.8 % Carbon Black 1; 4 = 1.2 % Carbon Black 2; 5 = 1.7 % Carbon Black 3

These test samples and many others allow conclusions to be drawn about the stability of the entire system and not just of the pigments used. It has been found in many cases that various pigments, for example, carbon blacks or certain organic pigments do not have adequate weather stability. Photos 7 and 8 show concrete masonry blocks and

calcium silicate brick colored with various black pigments after outdoor weathering for around 25 years. Photo 9 shows concrete pavers after outdoor weathering for two years in Den Helder, The Netherlands. The carbon black pigment used has already faded in this relatively short period of time. The most important conclusion to be drawn from this, apart from the familiar fact that certain pigments are not stable enough, is that this fading process is irreversible and not merely a temporary phenomenon.

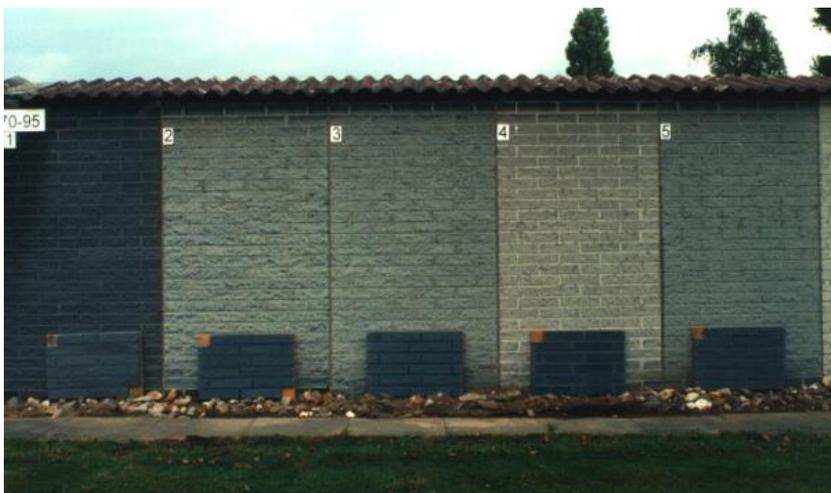
**Photo 8: Calcium silicate bricks (unweathered reference samples in foreground) Weathering commenced: 1970, Photo taken: 1995**

1 = 3 % Bayferrox 303 T; 2 = 1.1 % Carbon Black 1; 3 = 0.5 % Carbon Black 2; 4 = 0.9 % Carbon Black 3; 5 = 0.5 % Carbon Black 4

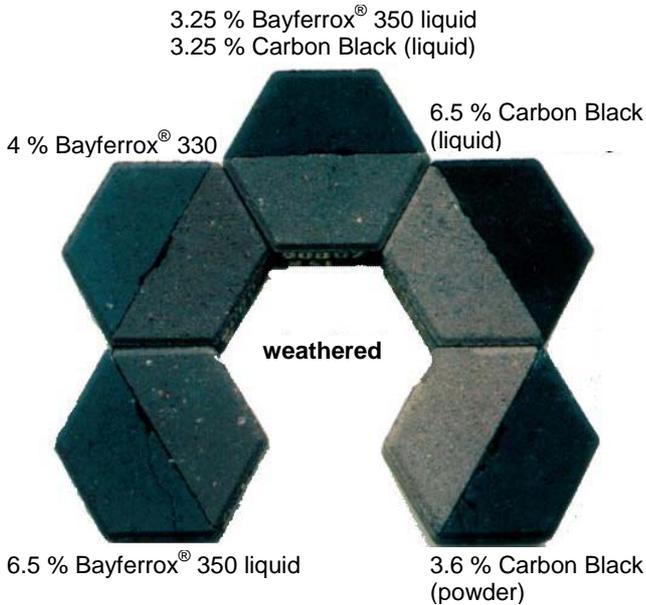
**Photo 9: Weather stability of black pigments, Concrete pavers, Weathering commenced: 1990, Photo taken: 1993**

- bottom left: 6.5 % Bayferrox<sup>®</sup> 350 liquid
- top left: 4 % Bayferrox<sup>®</sup> 330
- middle: 6.5 % Bayferrox<sup>®</sup> 350 liquid/Carbon Black 5 (1 : 1)
- top right: 6.5 % Carbon Black 5
- bottom right: 3.6 % Carbon Black 5

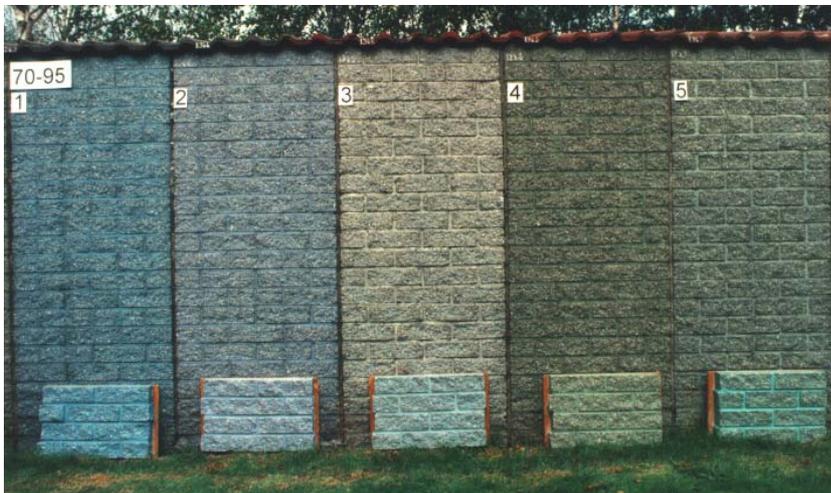
**Photo 10: Concrete masonry blocks (unweathered reference samples in foreground) Weathering commenced: 1970, Photo taken: 1995**

- 1 = 3 % Lightfast Blue 100; 2 = 3 % Lightfast Blue 2 R; 3 = 0.2 % organic Blue pigment;
- 4 = 3 % Chrome Oxide Green GN; 5 = 0.5 % Organic Green pigment

Photos 10 and 11 show various blue and green pigments used in concrete masonry blocks and calcium silicate brick and tested for their long-term stability. Here too, it can be seen that there are considerable differences in the weather stability of the various pigments. Chrome oxide green or cobalt oxide spinel blue provide durable color in the pigmented building materials. It should be pointed out again that the fading of organic pigments is an irreversible process, i.e. not merely a temporary phenomenon. Numerous authors [1, 2] have discussed this subject in great detail.

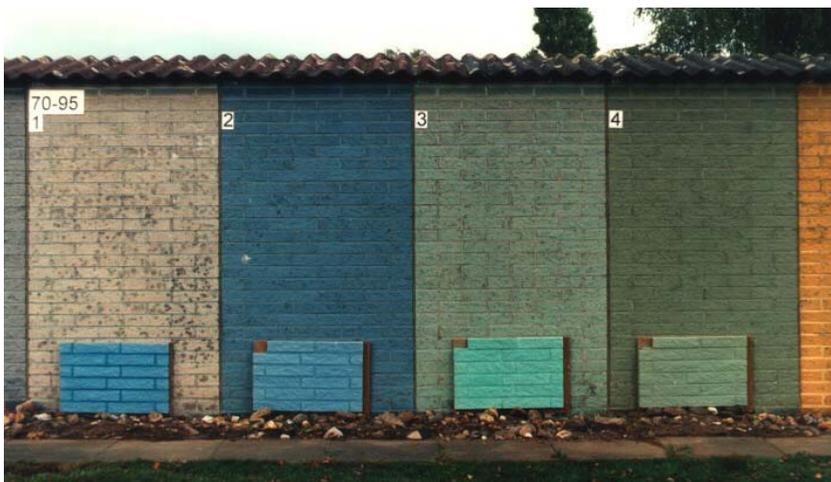
**Photo 11: Calcium silicate bricks (unweathered reference samples in foreground) Weathering commenced: 1970, Photo taken: 1995)**

- 1 = 0,075 % Organic Blue pigment, 2 = 1 % Lightfast Blue 100, 3 = 0,15 % Organic Green pigment, 4 = 1 % Chrome Oxide green GN

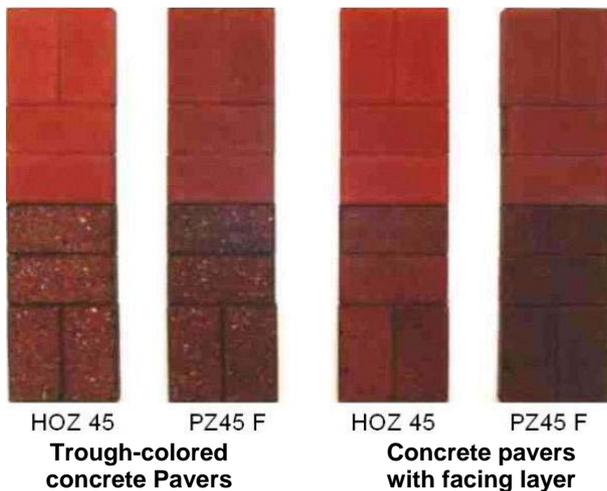
**Photo 15: Concrete pavers produced using different cements, colored with 5 % Bayferrox® 130**

pigments used and the stability of colored concrete systems of varying composition. Photo 15 shows a selection of the oldest test samples.
